DELAWARE RIVER BASIN  
LAKE JEFFERSON DAM

SULLIVAN COUNTY NEW YORK  
INVENTORY NO. NY 205

PHASE I INSPECTION REPORT  
NATIONAL DAM SAFETY PROGRAM

Name of Dam: Lake Jefferson (I.D. No. NY 205)  
State Located: New York  
County Located: Sullivan  
Stream: East Branch of Callicoon Creek  
(tributary of Callicoon Ck. & Delaware River)  
Date of Inspection: November 16, 1979

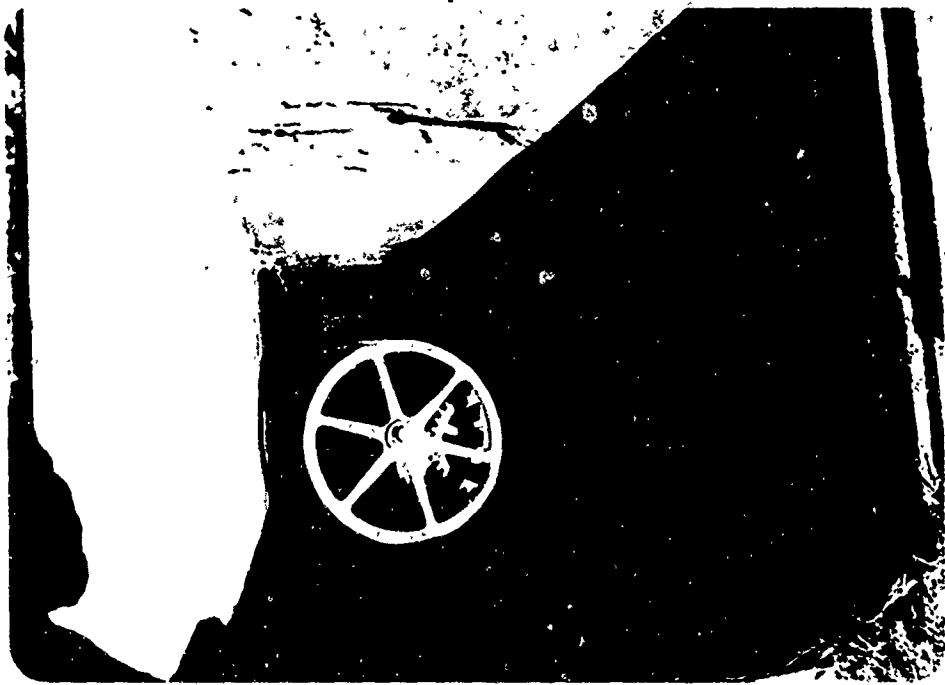
Reservoir Drain Valve  
Photo #9
